June 25, 2019

Per your request, as directed in the Scope of Work issued on June 12, 2019, Federal Occupational Health (FOH) conducted a Bed Bug Assessment and Basic Indoor Air Quality (IAQ) Evaluation of the Social Security Administration (SSA) Office of Hearing Operations (OHO) located in the Eastgate Metroplex at 14002 E. 21st Street Suite 1140 Tulsa, OK 74134. This work was conducted under the Interagency Agreement established between the General Service Administration (GSA) Region 7 and FOH. The purpose of this assessment was to evaluate this leased building space relative to past and current issues related to bed bugs in the facility.

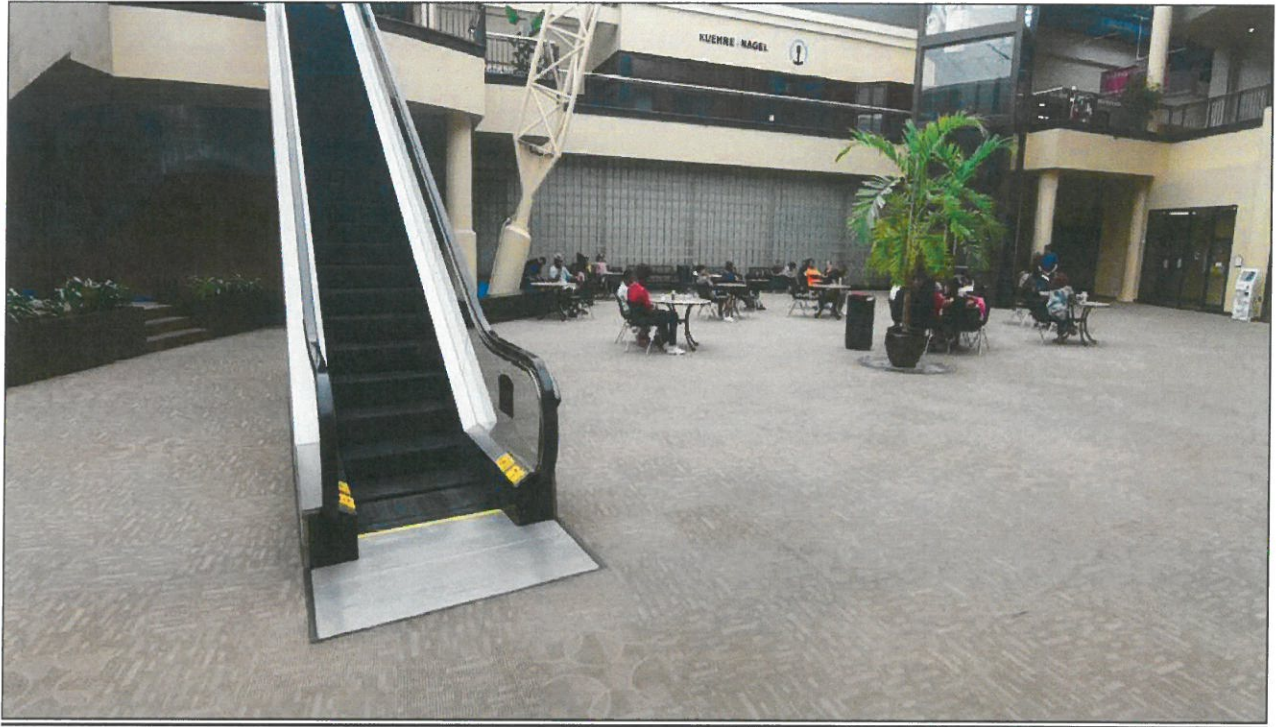
The visual inspection of the common public access areas, throughout the facility and immediately outside the SSA office, was found to be clean and in good repair (see Photo 1). All carpet and other floor coverings appeared to be designed for use in high traffic public areas and were properly installed and clean (see Photo 2). All wall and ceiling areas were also found clean and dry. All furniture in these areas was made of plastic and/or metal and consisted of non-upholstered non-porous materials (see Photo 3). All building and components and furnishings were easily accessed and cleanable. The types of building products and furniture in this area would be consistent with efforts to control the potential harborage of bed bugs or other pests. The only issue found in this Metroplex common areas involved the hollow and, in some cases, open ended metal and plastic tubing composing the chairs and furniture structure that allows for pest to gain cover and be concealed in these areas (see Photo 4). No conditions or circumstances in the unoccupied Metroplex floor space under the SSA facility and building main basement tunnel, would be suspect as contributing to the harborage of bed bugs or other rodents or pests. No other significant sources of chemical or dust contamination was found. No residual pesticide residue or staining was found on furniture of building components.

Photo 1 – Common Waiting Area - Eastgate Metroplex 14002 E. 21st Street Tulsa, OK 74134

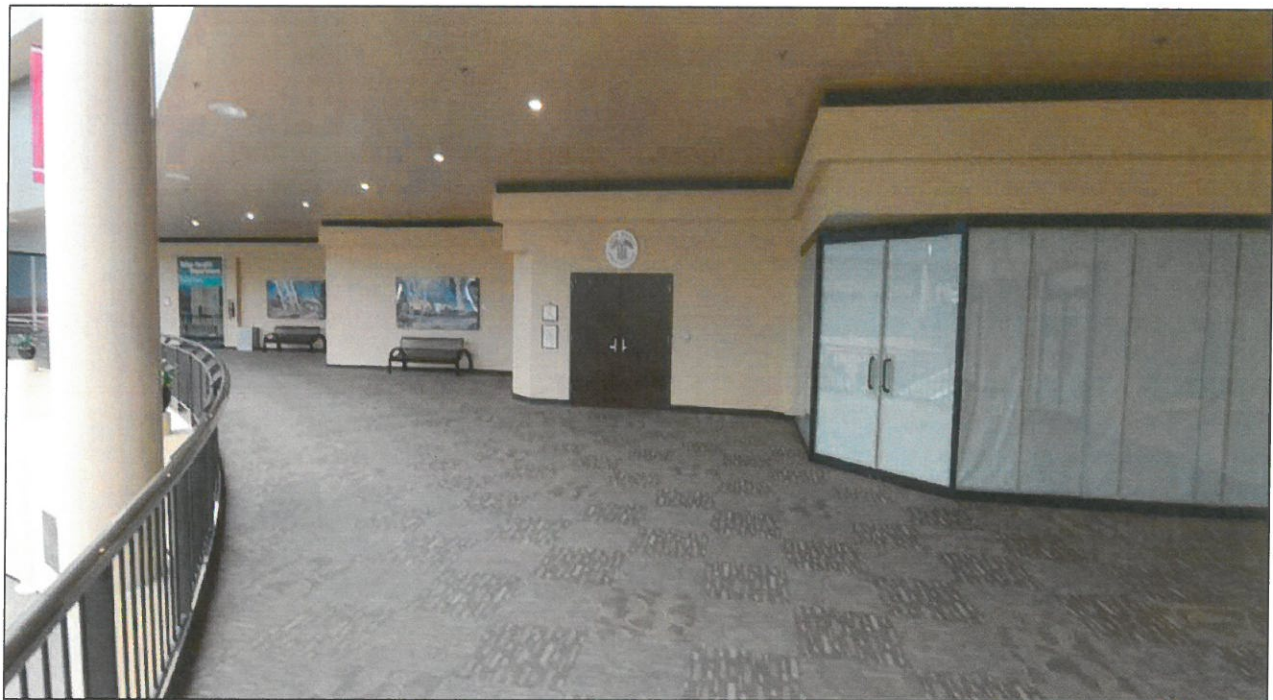
Photo 2 – Common Hallway Area - Eastgate Metroplex 14002 E. 21st Street Tulsa, OK 74134

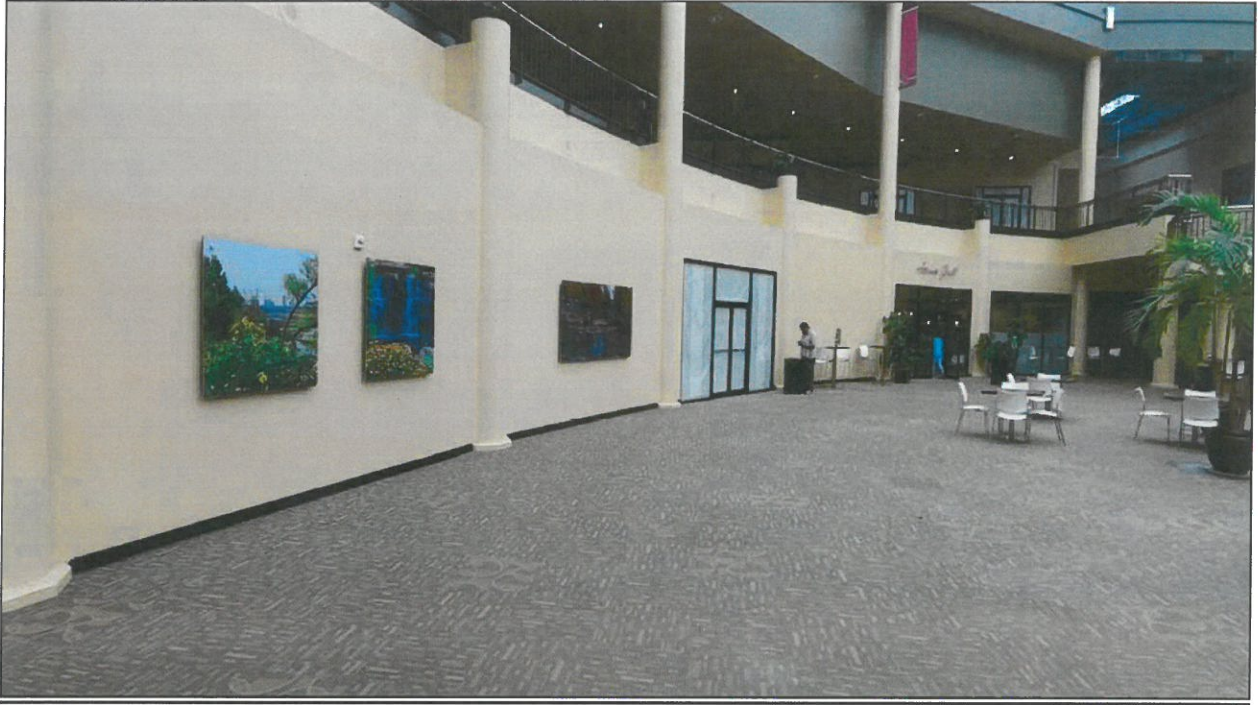
Photo 3 – Common Area Furniture - Eastgate Metroplex 14002 E. 21st Street Tulsa, OK 74134

4. All chairs and other furnishing should be inspected, cleaned and treated on a scheduled and routine basis to assure no ongoing pest harborage.
5. Framed wall hangings and photos above seating in the common areas and SSA space, should be inspected, cleaned and treated routinely to assure bed bugs are not attaching to and finding harborage on the backs of these objects.

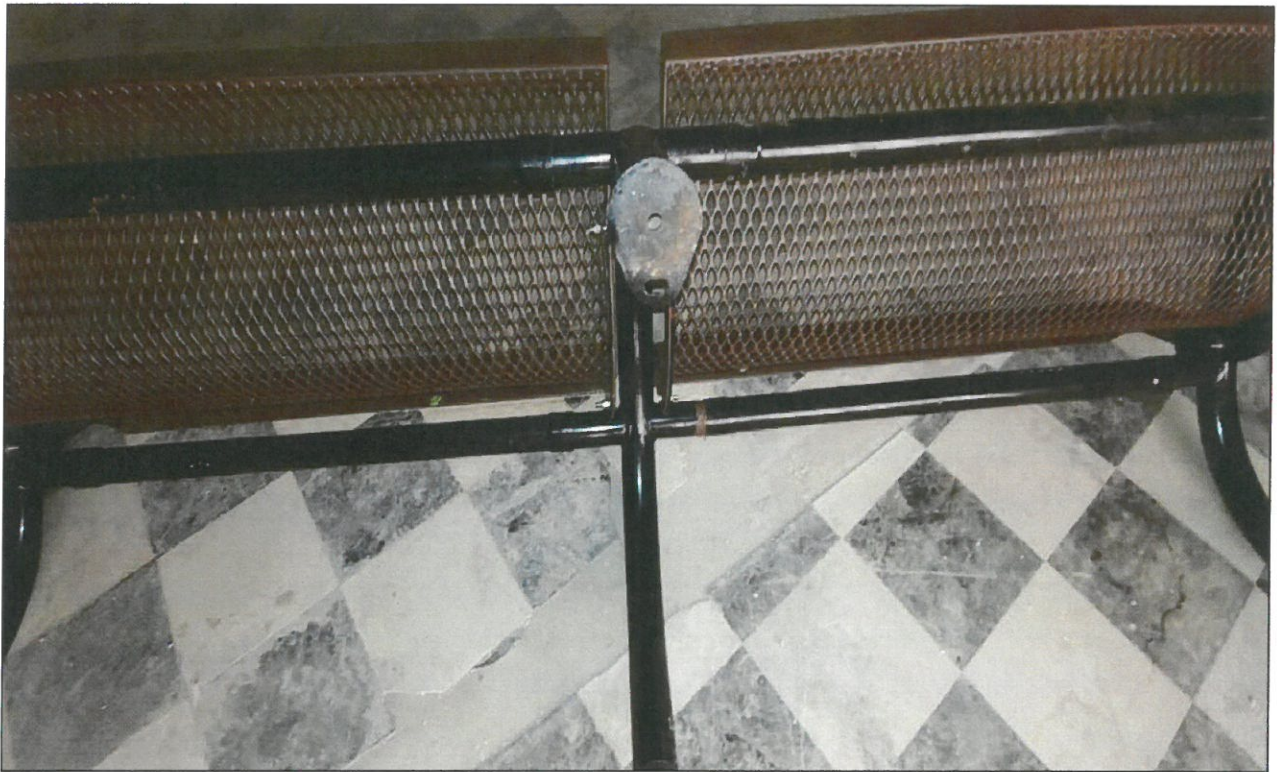
**Photo 4 – Office Furniture Metal Tubing Openings
Eastgate Metroplex 14002 E. 21st Street Tulsa, OK 74134**

3. Current holes and openings in the tubular metal benches and chairs should be sealed with caulking or filler material to not allow bugs concealment or access to these hidden and hard to inspect locations. Where possible pockets or crevices in chair and furniture components should also be sealed as best as possible.

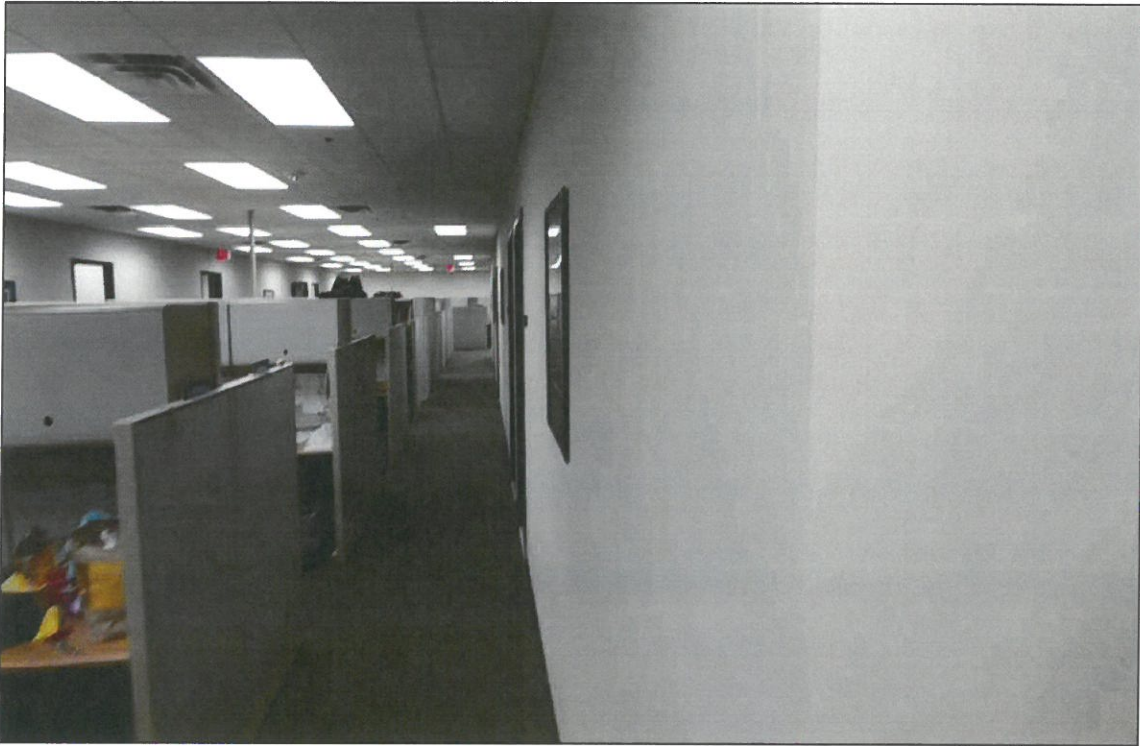
The SSA OHO space was also found to be very clean, organized and well maintained (see Photo 5). All carpets and floor coverings were in excellent condition and free of excessive dirt or staining (see Photo 6). All painted sheetrock walls were also clean, in excellent condition with no moisture or other staining observed. The ceiling tiles throughout the space were clean and dry. However, two locations were found where ceiling tiles have been water stained (see Photo 7). All office fabric covered cubicle dividers, other furniture, desks, files, chairs were also very clean, dry and maintained. All equipment and supply storage rooms were very organized, clean and dry. The chairs and other furniture in the public access areas of this office, were made of metal and/or plastic and of a non-porous easily cleanable material (see Photo 8). All components of the heating, ventilating, and air-conditioning (HVAC) system(s) for this space were found to be clean, dry and well maintained. Pesticides have been used in this area to treat for bedbugs, however, no pesticide staining or residue was found on any building components or fixture and no sources of chemical or dust contamination were found in the space. The only chemical-based products used in the area are over the counter cleaning and maintenance products. No conditions or circumstances were

Photo 5 – SSA OHO Area - Eastgate Metroplex 14002 E. 21st Street Tulsa, OK 74134

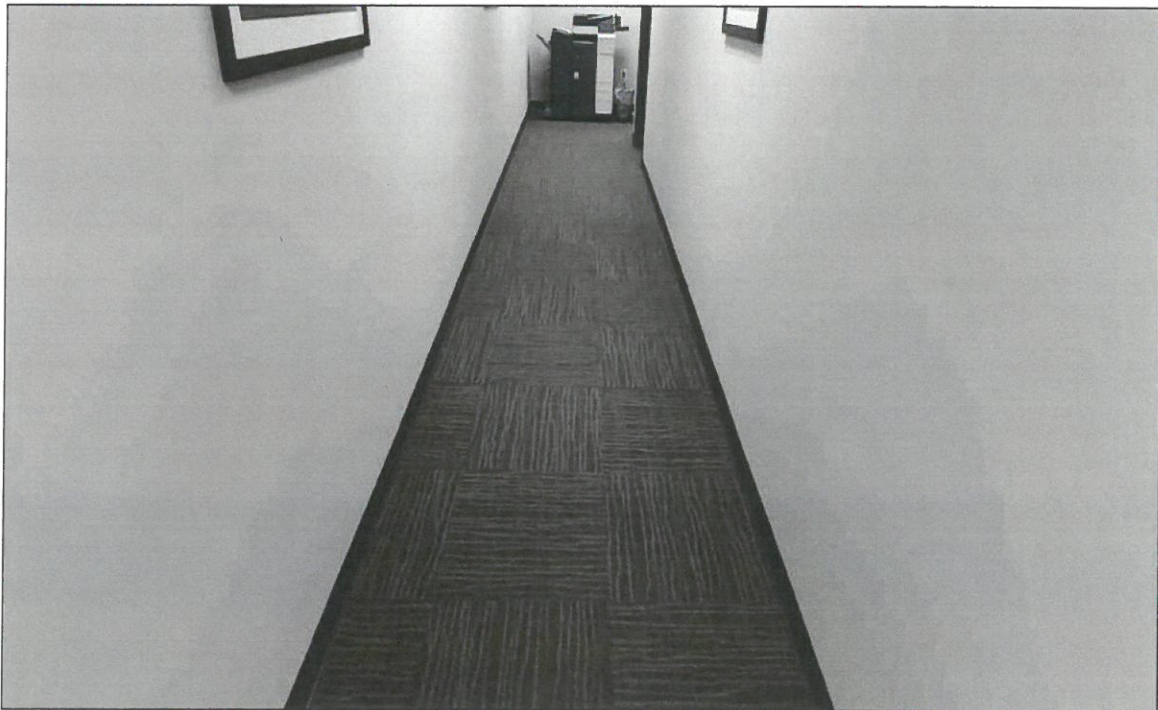
**Photo 6 – SSA OHO Area Carpet, Walls and Ceilings
Eastgate Metroplex 14002 E. 21st Street Tulsa, OK 74134**

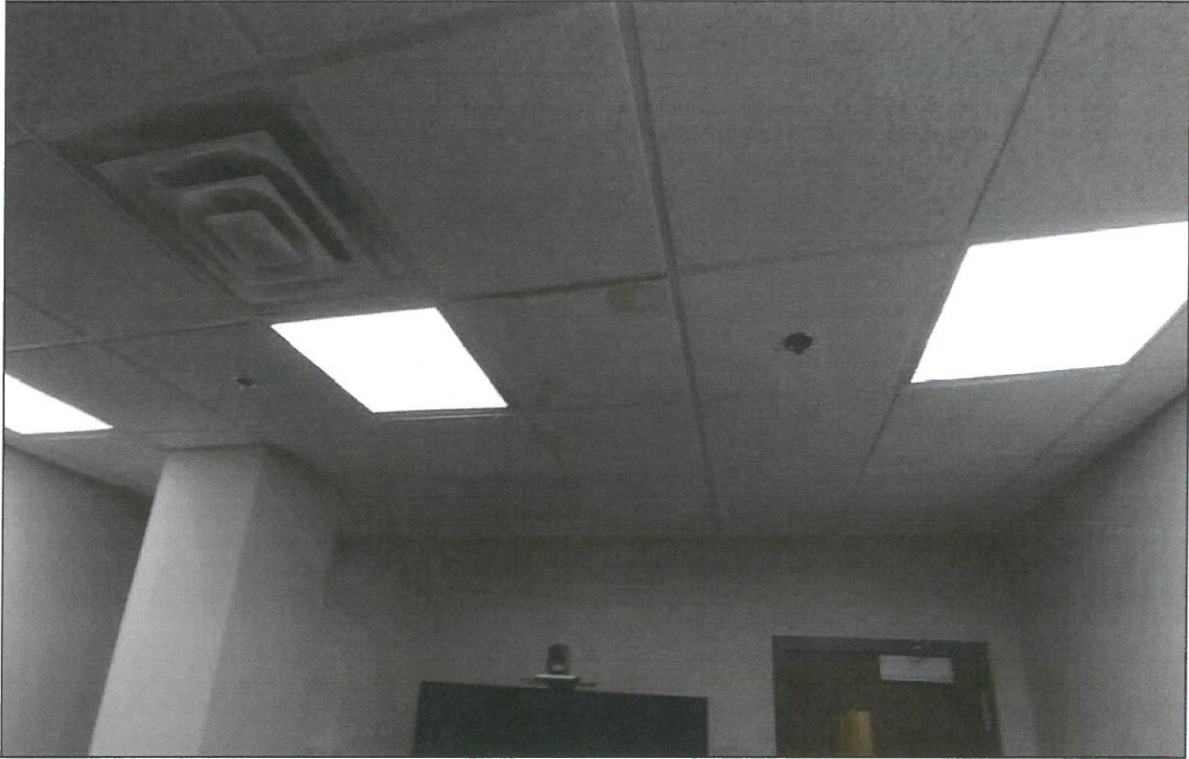
**Photo 7 – Water Stained Ceiling Tiles SSA OHO
Eastgate Metroplex 14002 E. 21st Street Tulsa, OK 74134**

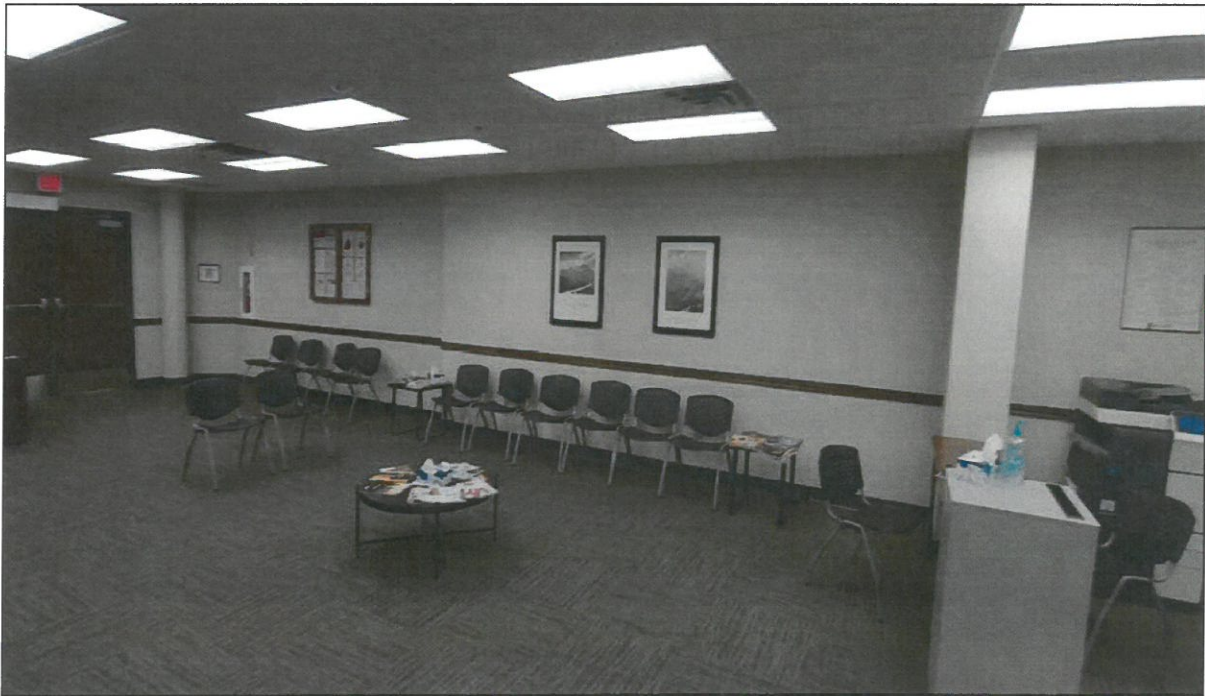
**Photo 8 – Waiting Room Seating/Furniture SSA OHO
Eastgate Metroplex 14002 E. 21st Street Tulsa, OK 74134**
